TECHNICAL REPORT CERC-85-8

BREAKWATER REHABILITATION STUDY, CRESCENT CITY HARBOR, CALIFORNIA

Coastal Model Investigation

Coastal Engineering Research Center

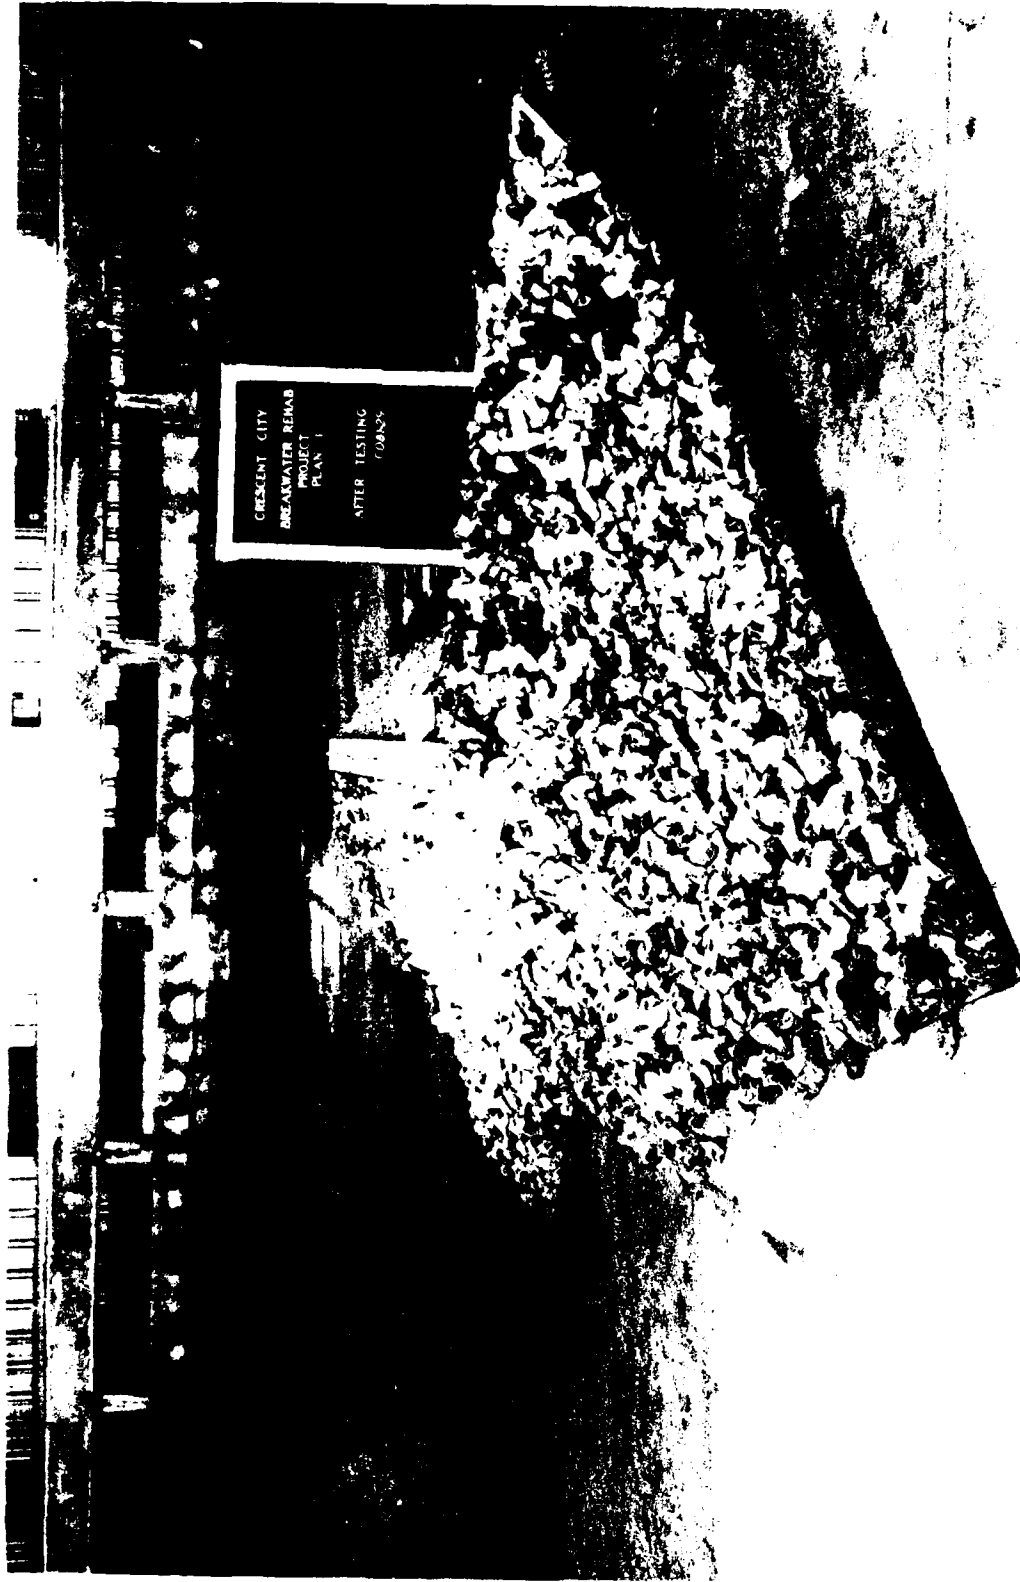
Photo 13. Seaward end view of Plan 1 after completion of abbreviated hydrograph

28. Plan 1 (Plate 6 and Photos 7-10) was constructed with the toe of the rehabilitation dolos 98 ft from the outer edge of the cap. A total of 177 dolosse were used. Damage to the structure was severe, and the entire toe area was displaced. Damage originated at the toe, and as the toe units were displaced the units upslope unraveled. The dolosse flukes extended above the still water level (swl) at the toe of the rehabilitation area for all water depths. Therefore, it was decided that the toe of the dolos would have to be placed in deeper water to remove it from the high wave energy region around the swl. Photos 11-14 show the structure after testing.

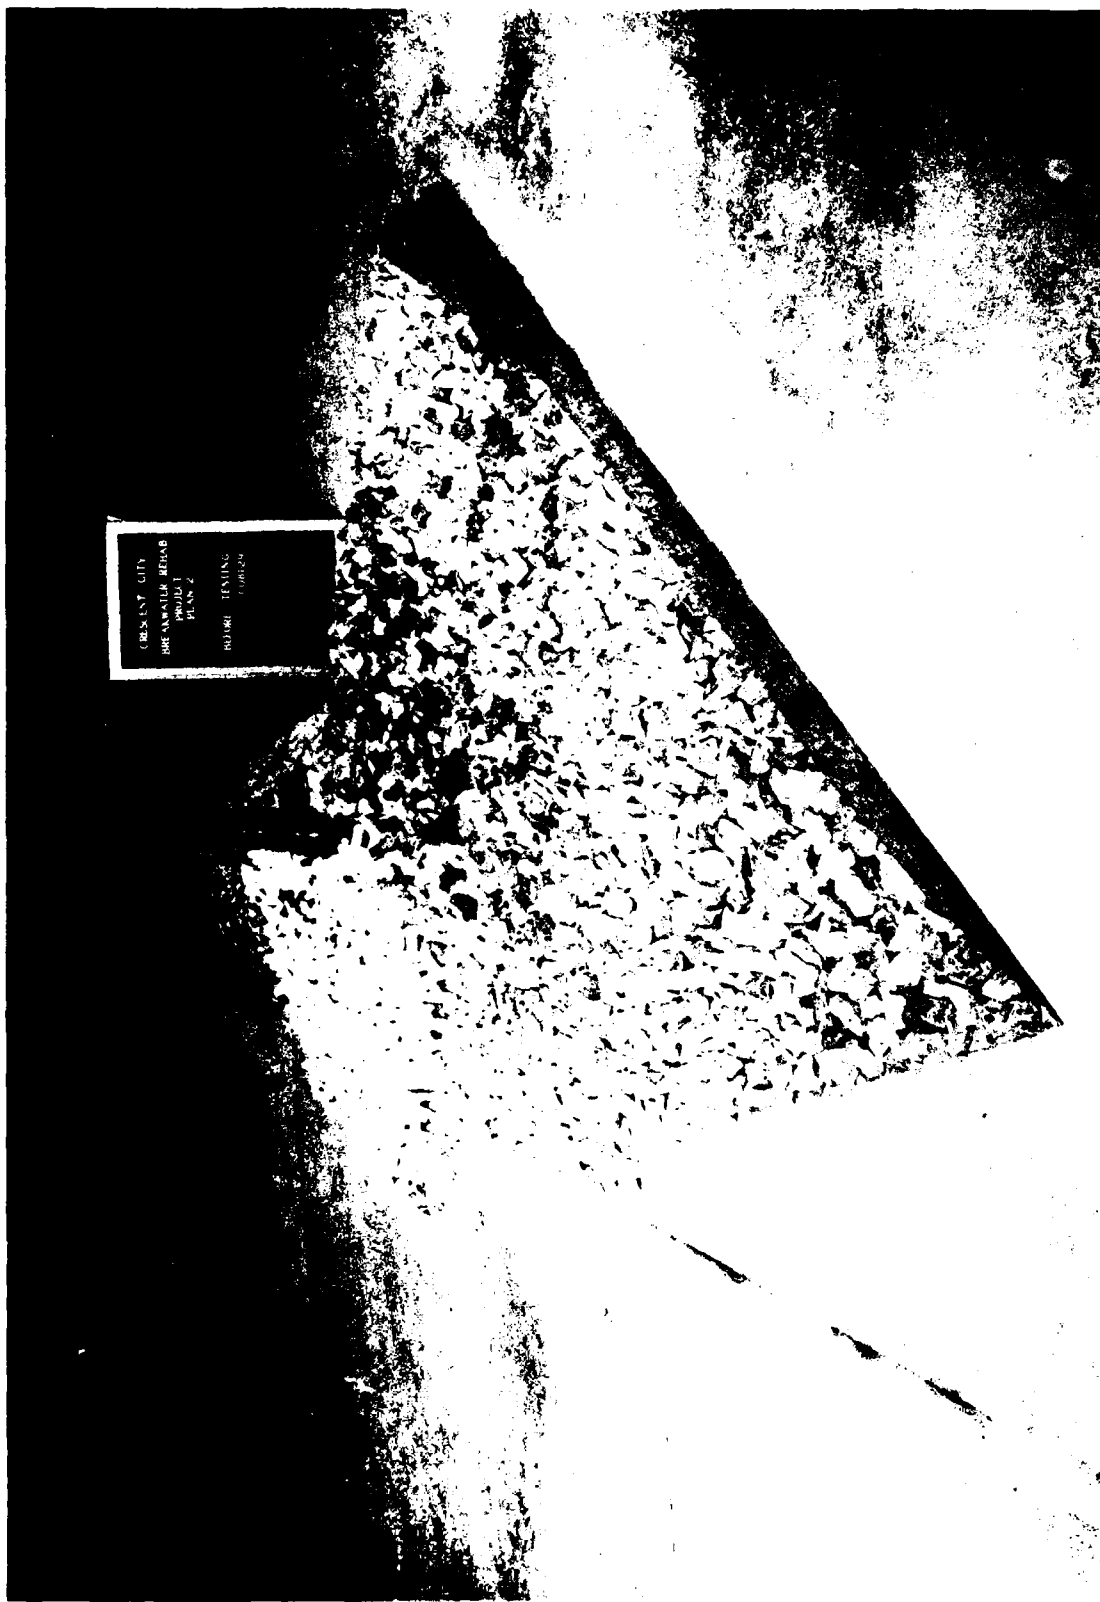
Photo 17. Seaward end view of Plan 2 before wave attack

29. Plan 2 (Plate 7 and Photos 15-18) was constructed with the toe of the rehabilitation dolos 160 ft from the outer edge of the cap. A total of 381 dolosse were used. The toe units in the left (shoreward) transition and central areas were stable; however, there was severe damage to the toe units in the right (seaward) transition area. The damage was occurring at the swl, and as the water depth was increased the damaged area moved upslope. Because of the geometry of the breakwater (i.e., the dogleg), wave energy is concentrated in this area and problems were expected in this region. Photos 19-21 show the structure after testing.

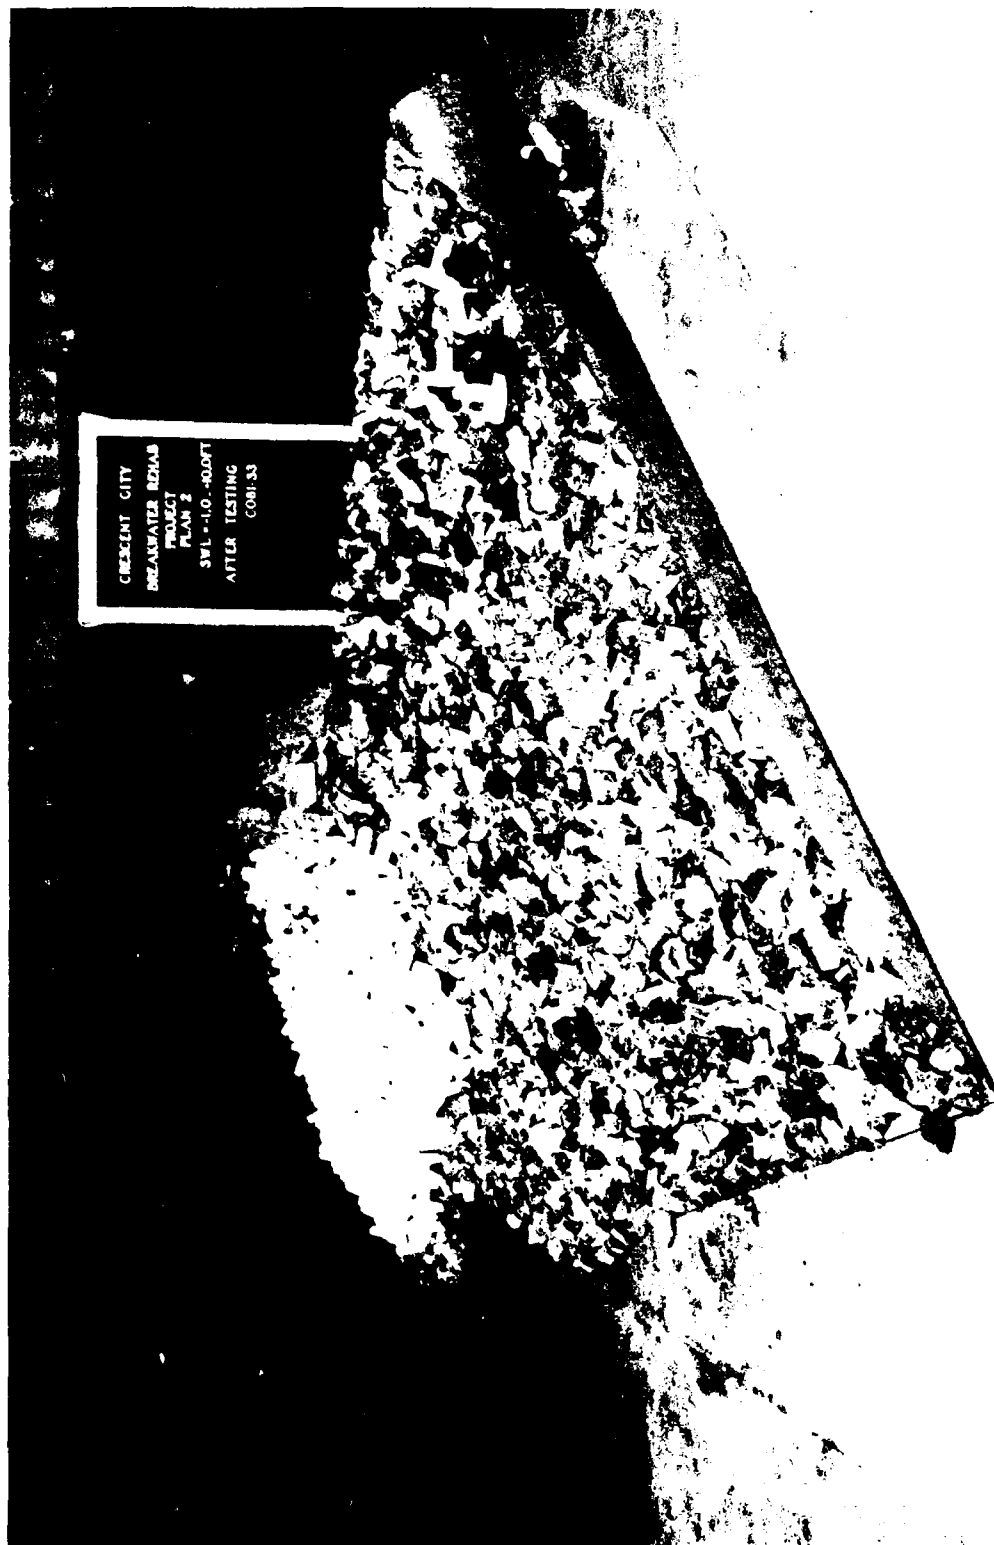
Photo 21. Seaward end view of Plan 2 after completion of abbreviated hydrograph

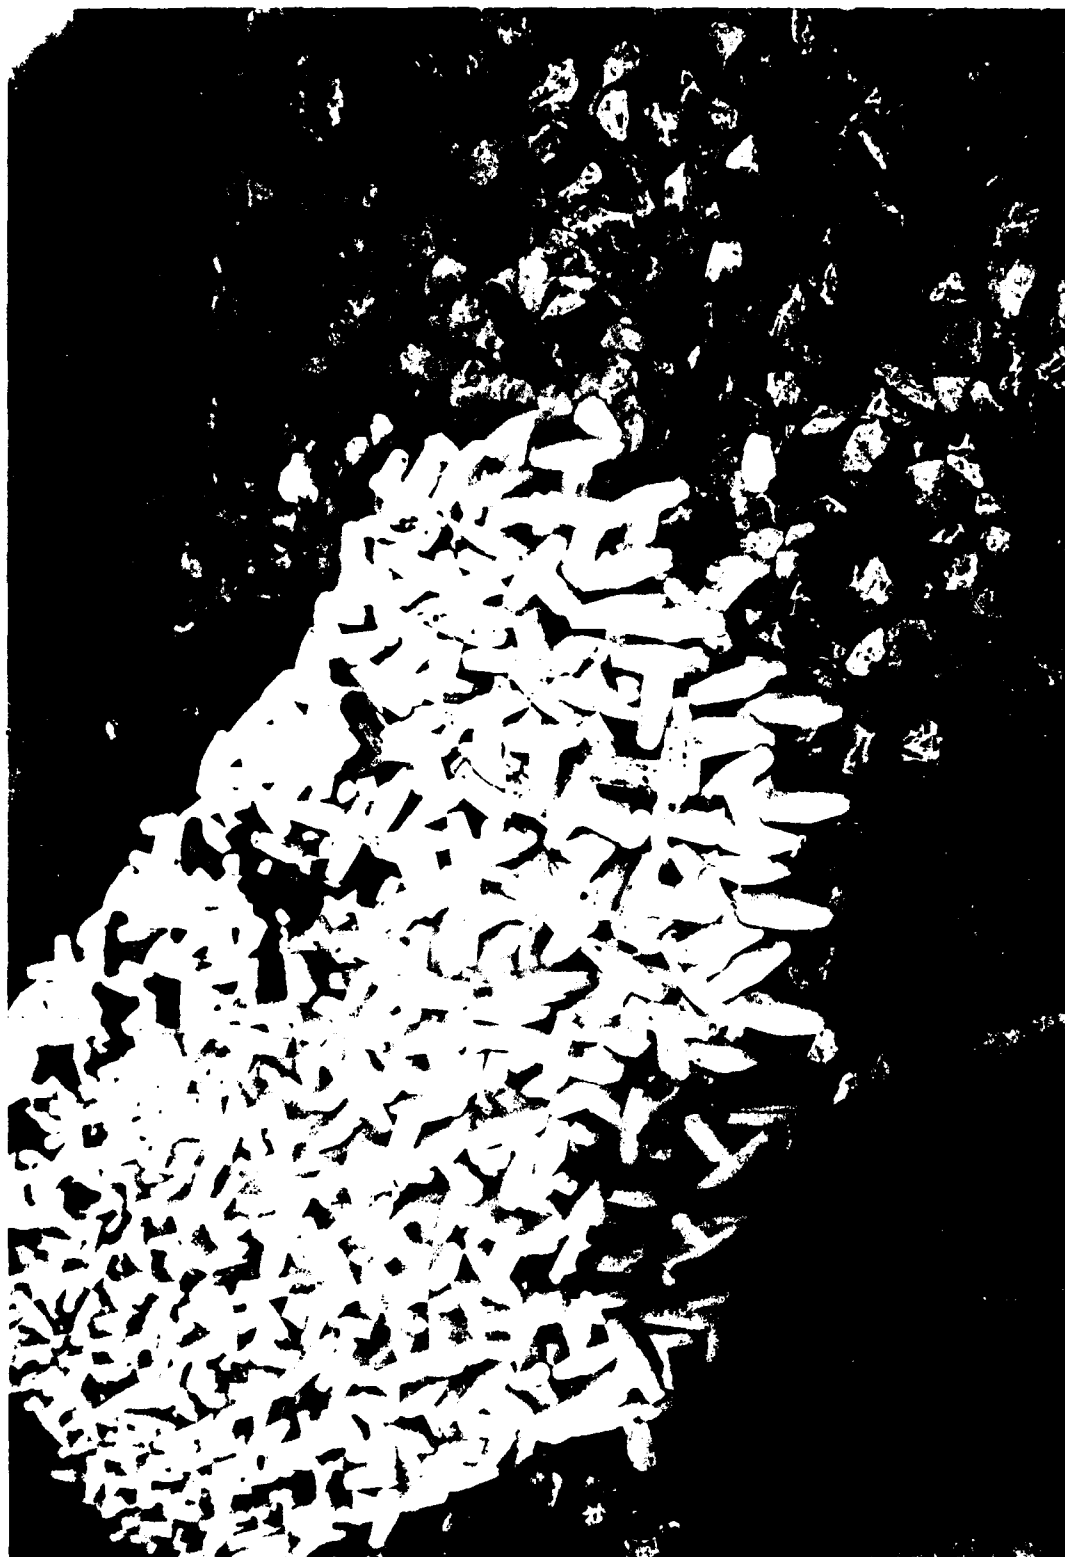
Photo 29. Special toe placement used for seaward transition of Plan 2B

31. Plan 2B (Plate 7 and Photos 27-28) was the same as Plan 2A, except that special placement was used for the toe units in the seaward transition area, i.e., the toe units in the second layer were placed to ensure double locking with the toe units in the bottom layer (see Photo 29). This plan performed less satisfactorily than Plan 2A in that failure was not gradual; the entire toe area failed as one unit. Tests conducted to date indicated that additional dolosse would be required to move the seaward transition further out the extension into a region where the wave action would probably be less severe. Photos 30-32 show the structure after testing.

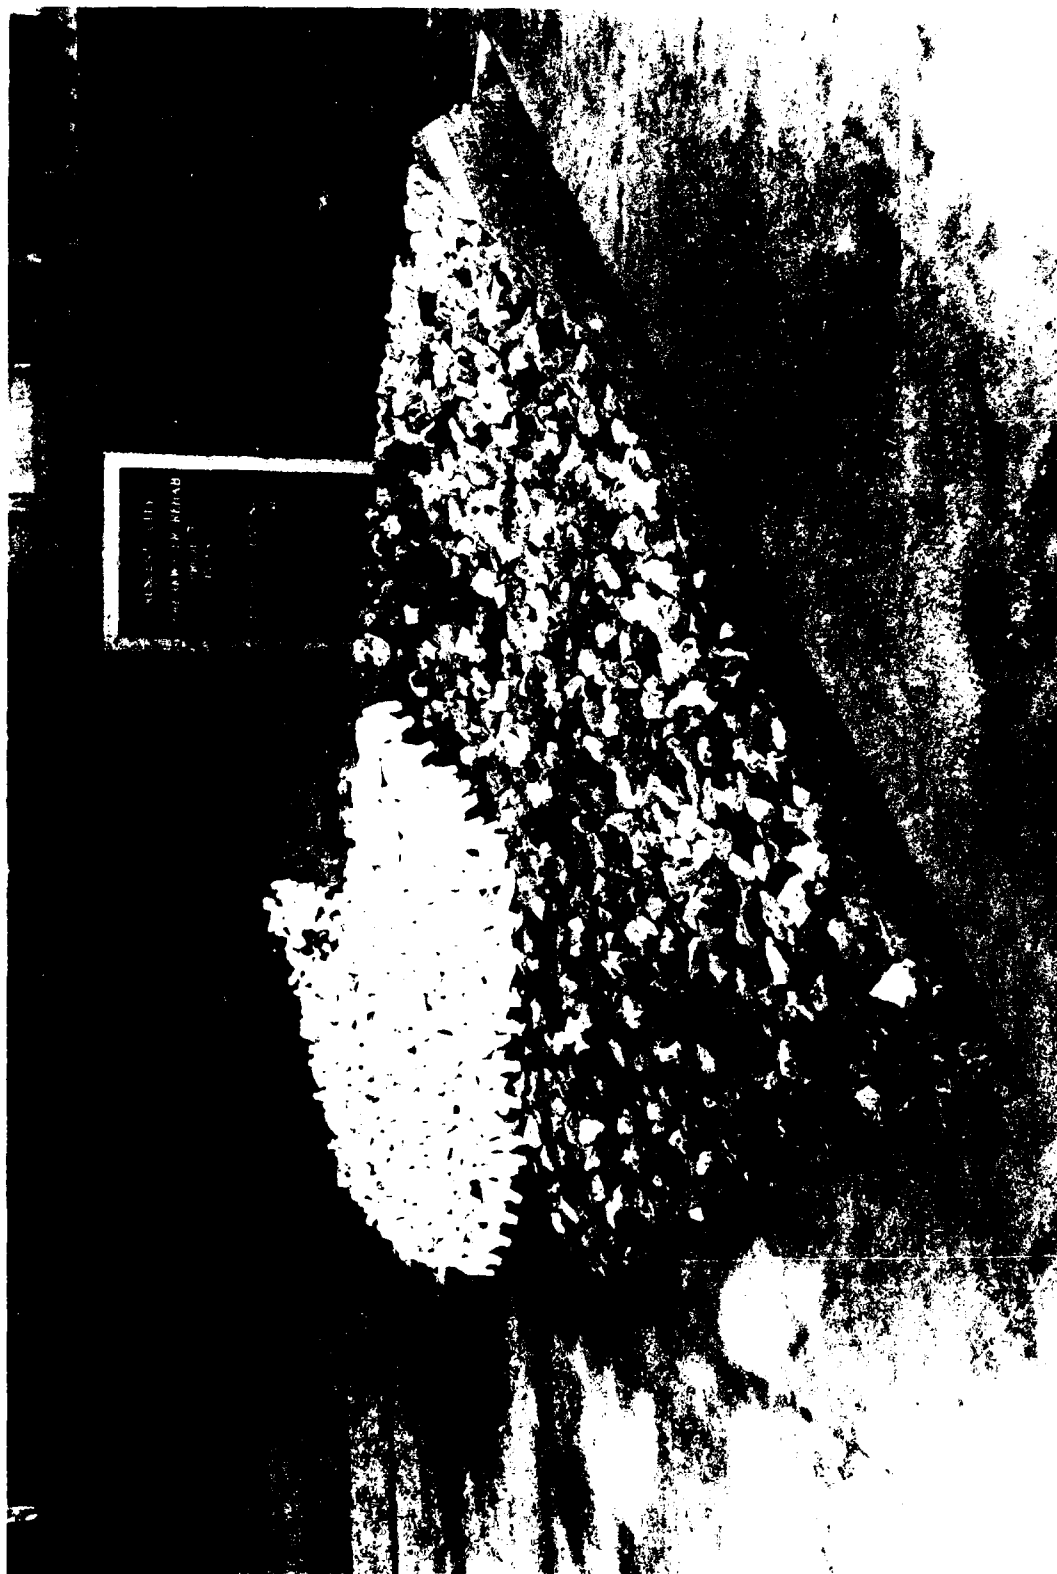
Photo 35. Seaward end view of Plan 3 before wave attack

32. Plan 3 (Plate 8 and Photos 33-35) was constructed with the toe of the dolos rehabilitation units still 160 ft from the outside edge of the cap; however, for this plan the dolos extended further out the eastern extension to sta 38+00. A total of 576 dolosse were used in the rehabilitation area. The lower corner of the seaward transition area now rested on material in the shoal area, and the flukes of these toe units were exposed for swl's of -1 and +4 ft. Damage originated in this location for these water levels and became severe for the +7-ft swl. Although there was less damage than for previous plans, the damage was still too excessive for the plan to be acceptable. Photos 36-38 show the structure after testing.

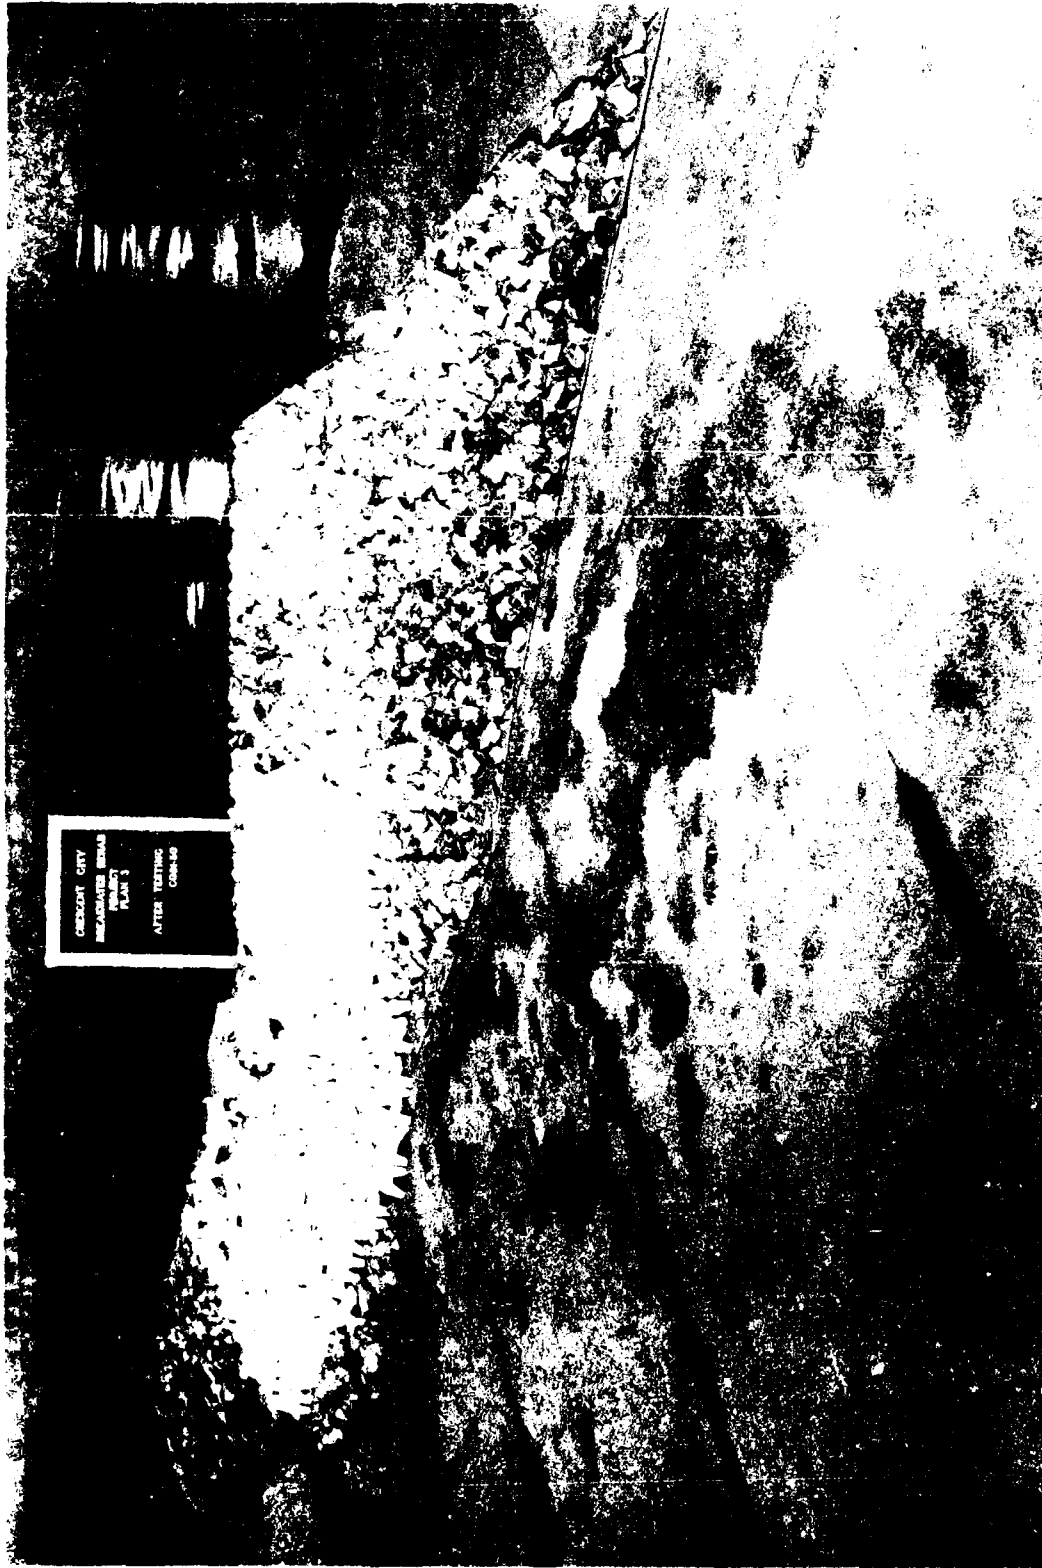
Photo 37. Seaward oblique view of Plan 3 after completion of abbreviated hydrograph

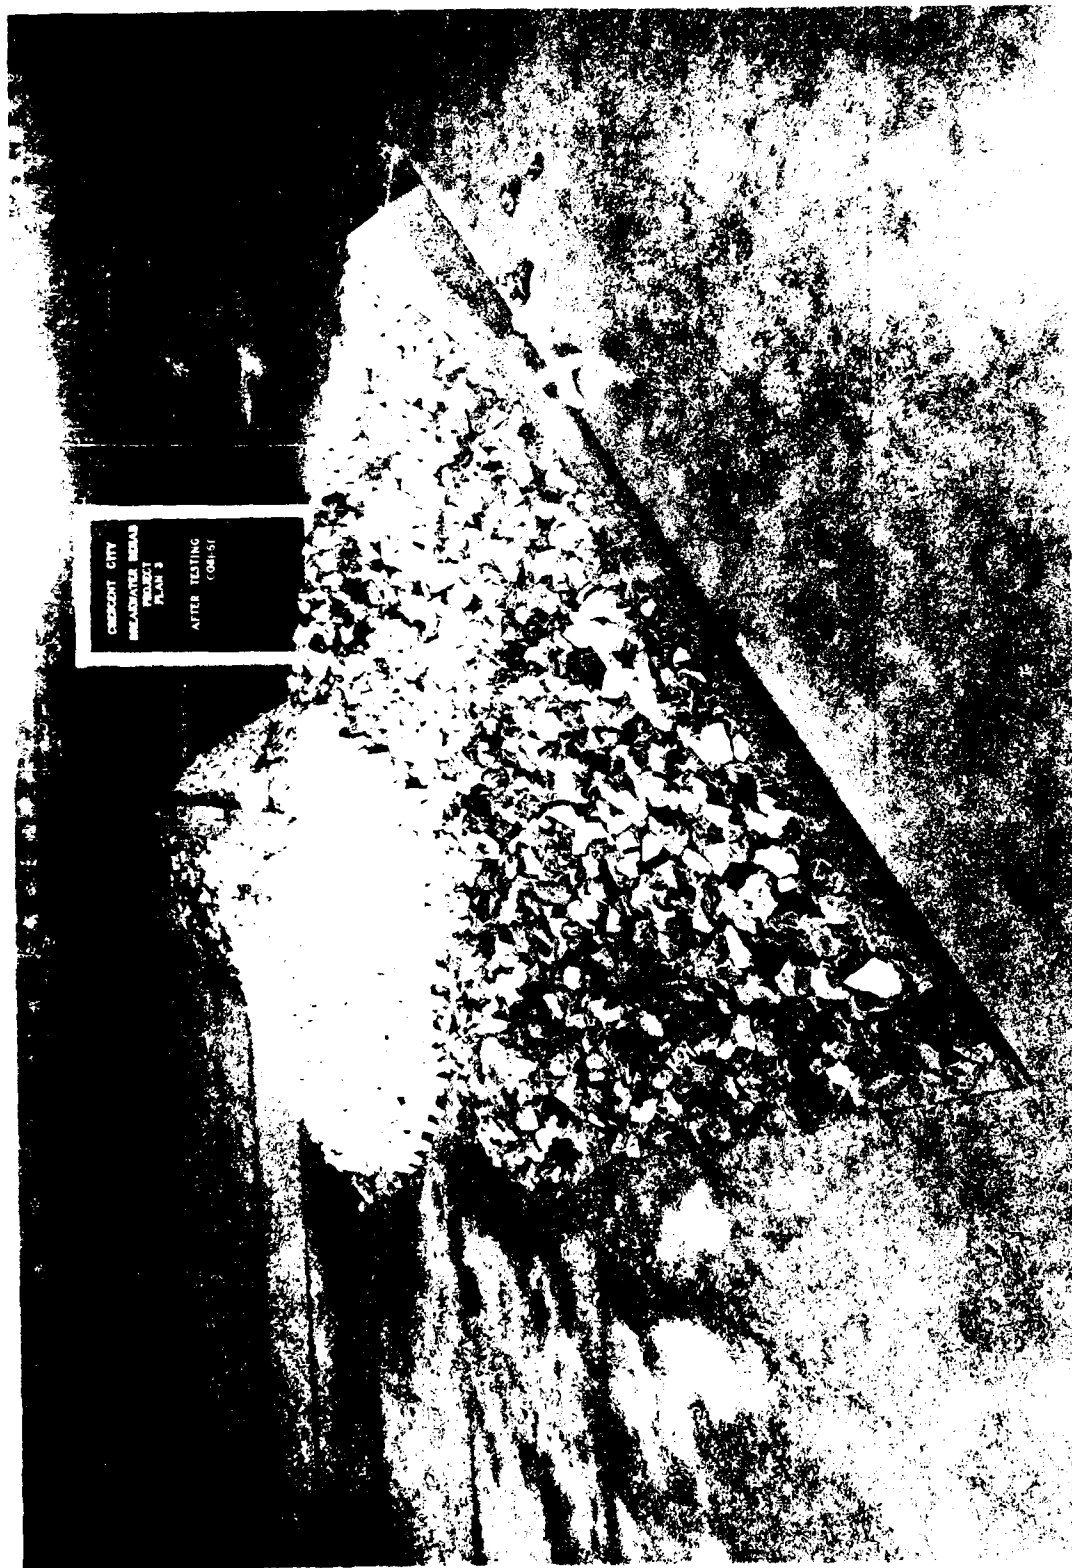
Photo 38. Seaward end view of Plan 3 after completion of abbreviated hydrograph

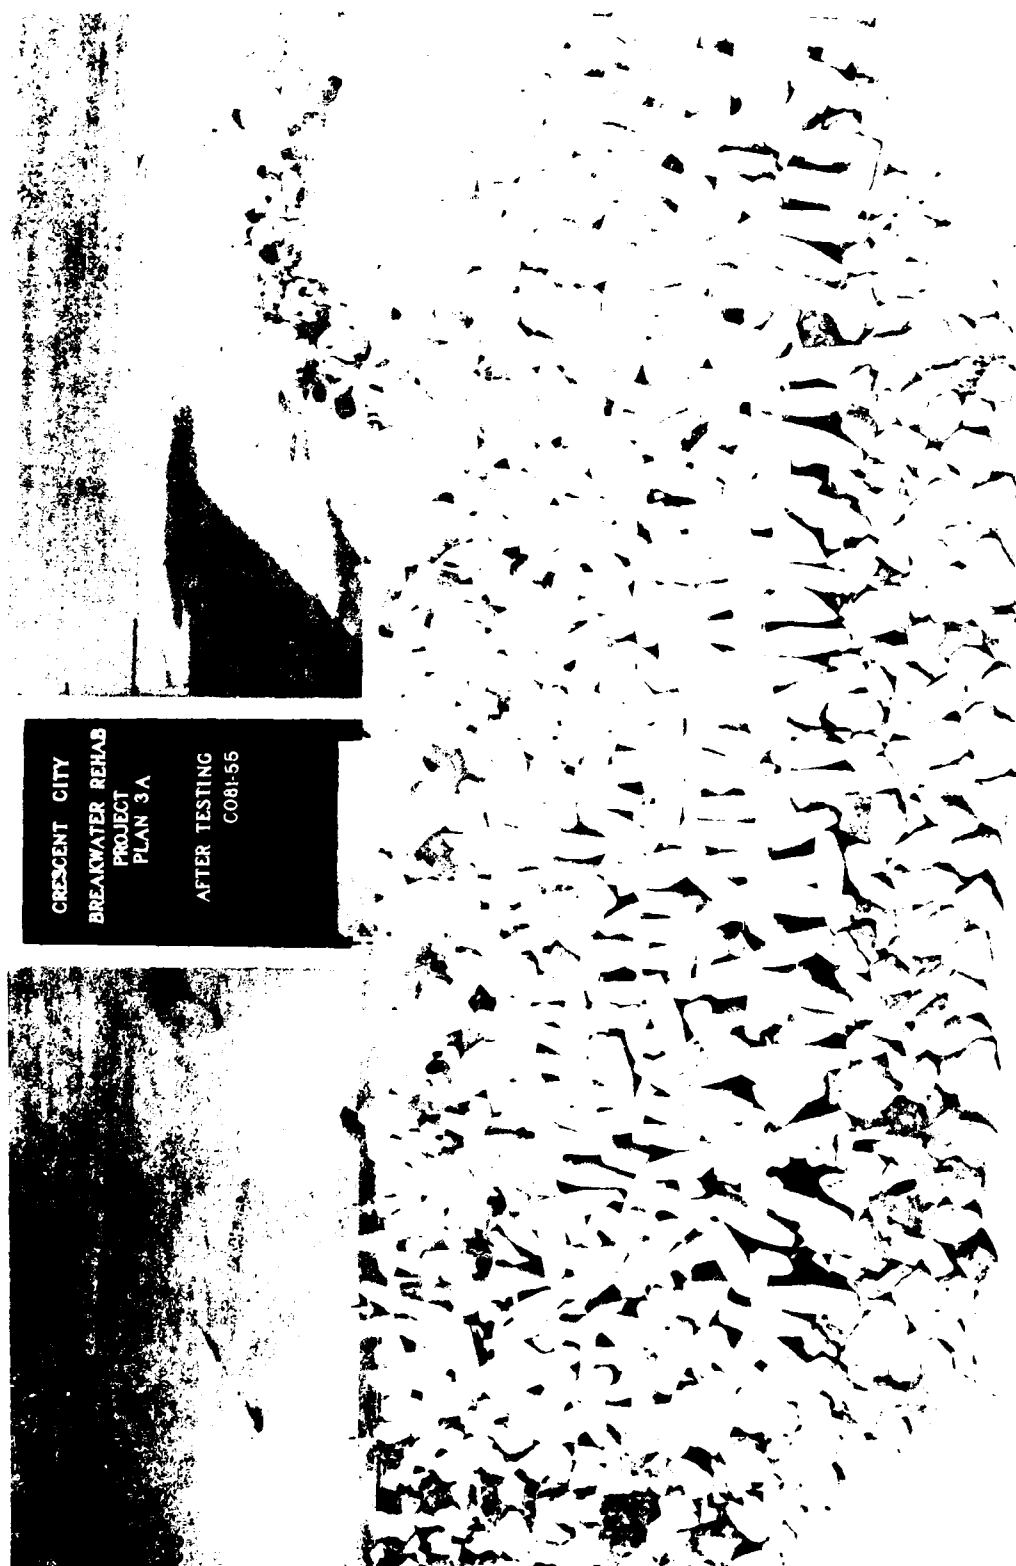
Photo 42. Sea-side view of Plan 3A after completion of abbreviated hydrograph

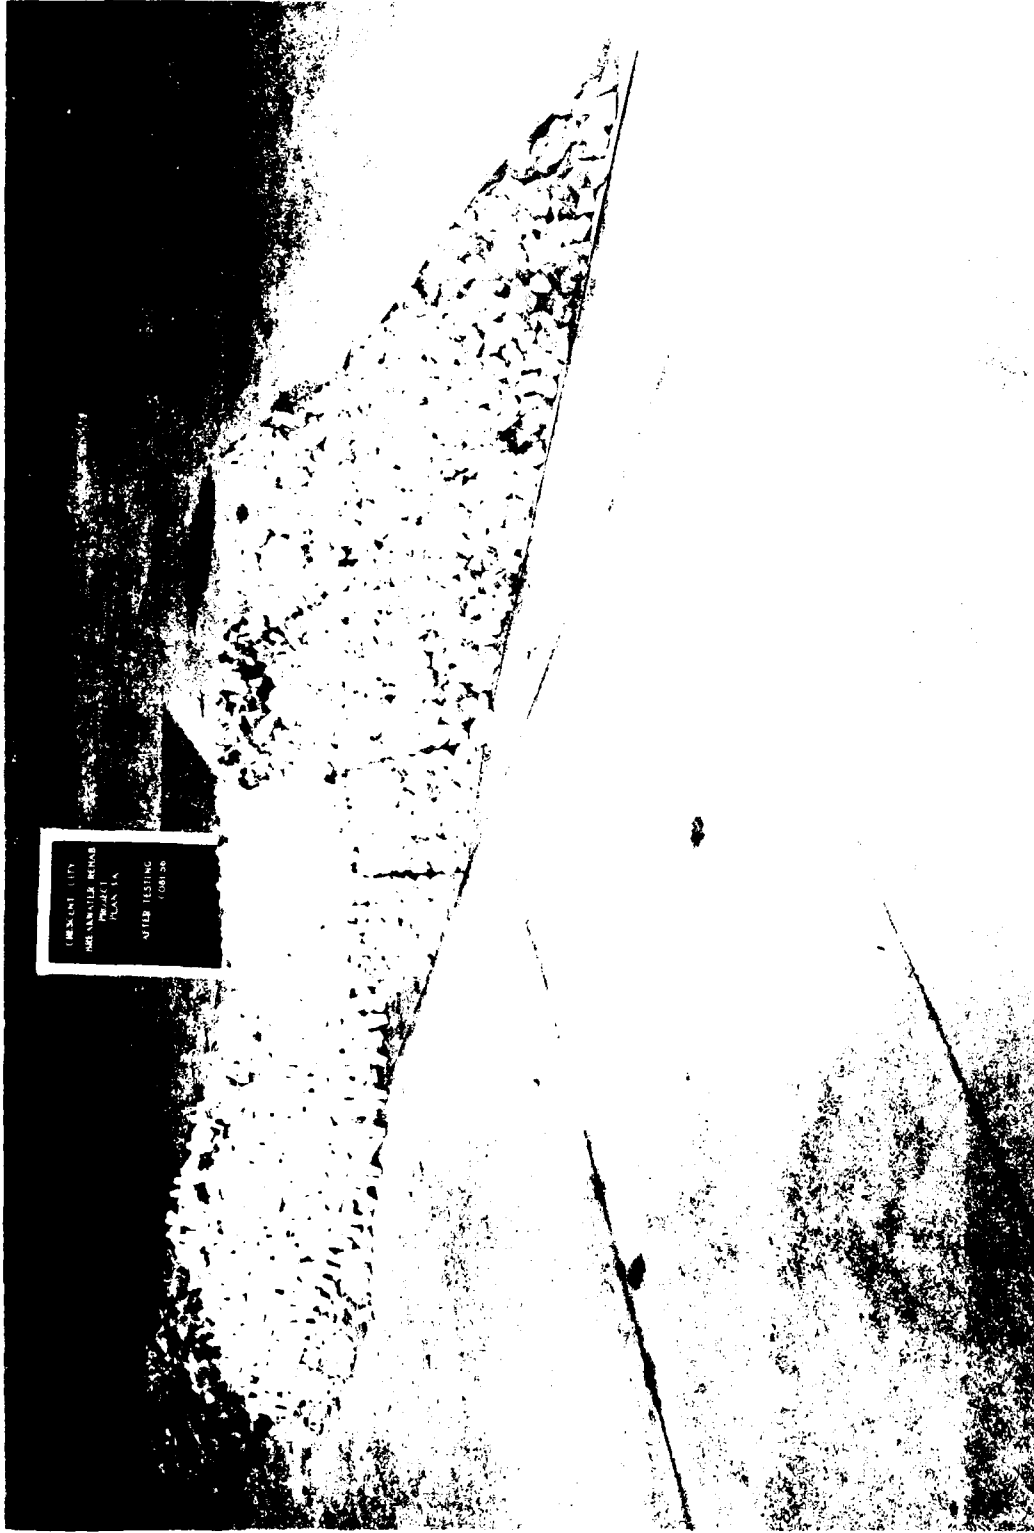
Photo 43. Seaward oblique view of Plan 3A after completion of abbreviated hydrograph

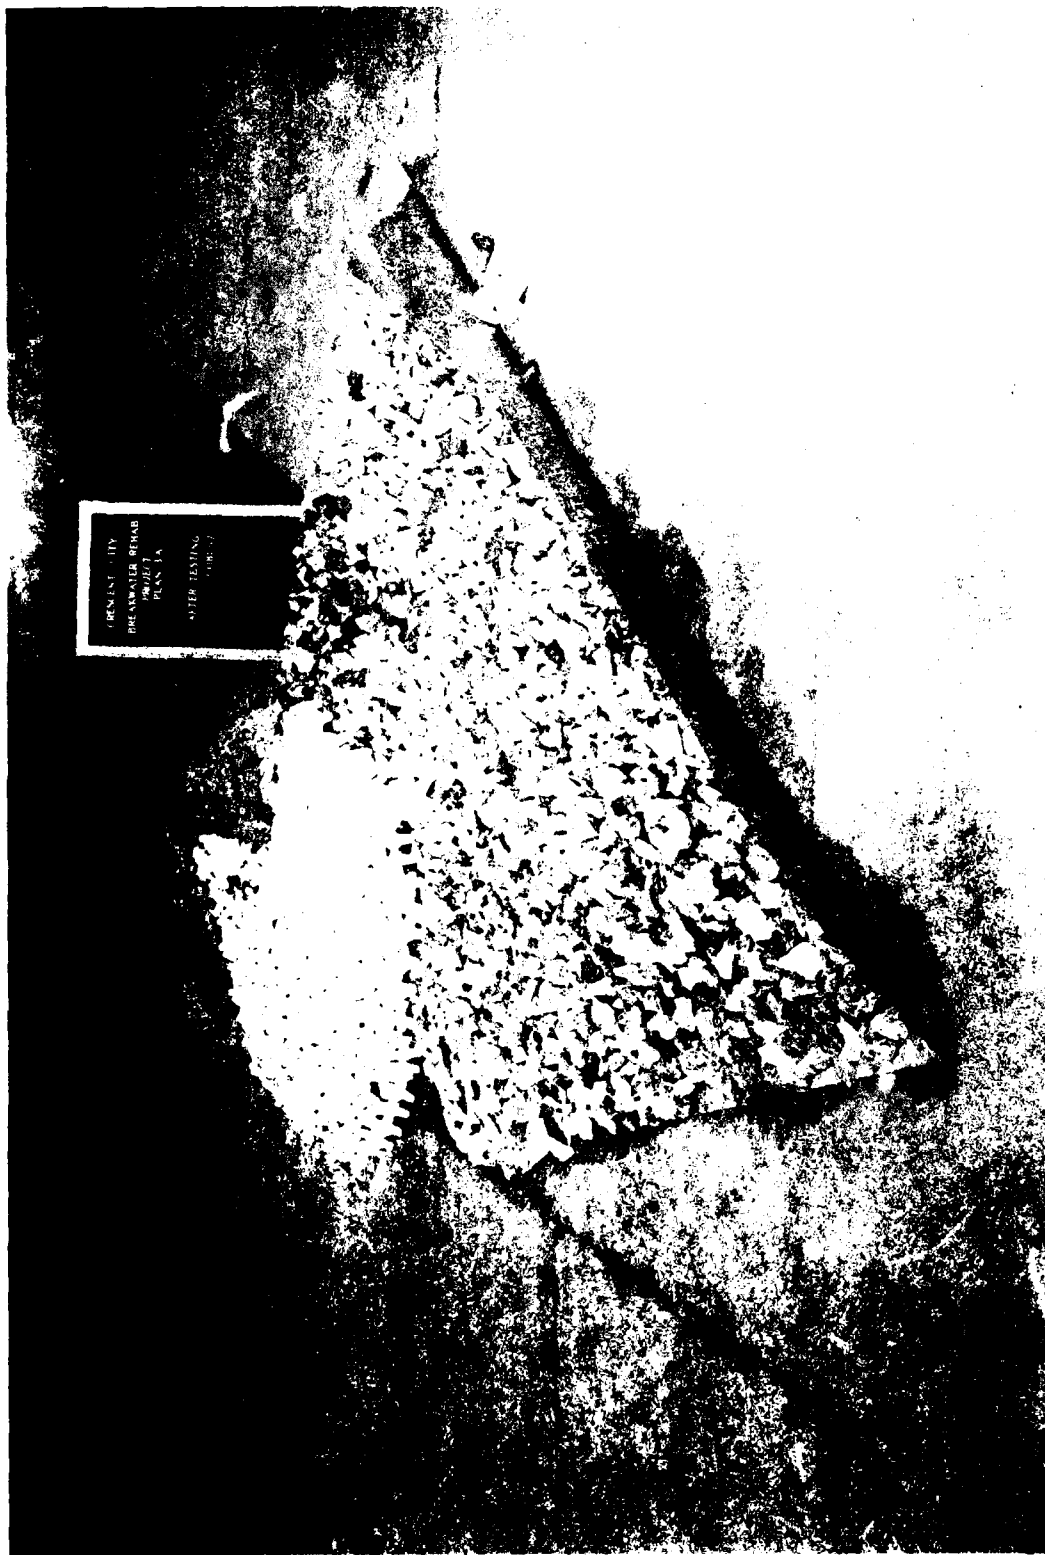
Photo 44. Seaward end view of Plan 3A after completion of abbreviated hydrograph

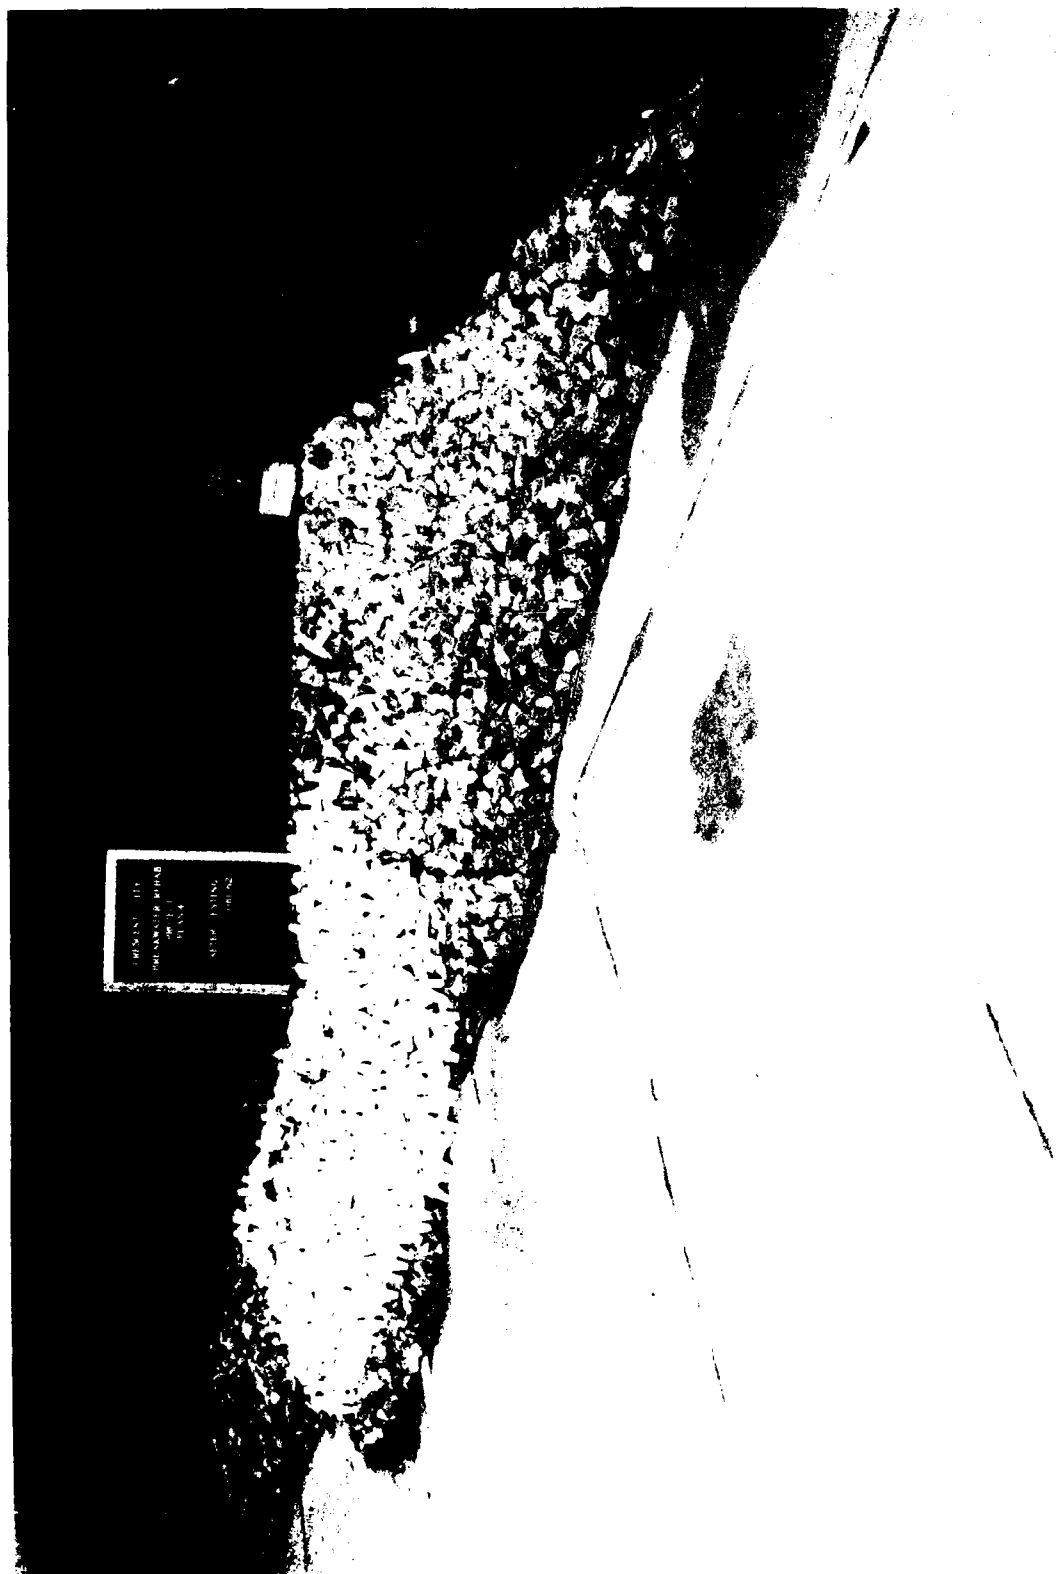
Photo 49. Seaward oblique view of Plan 4 after completion of abbreviated hydrograph

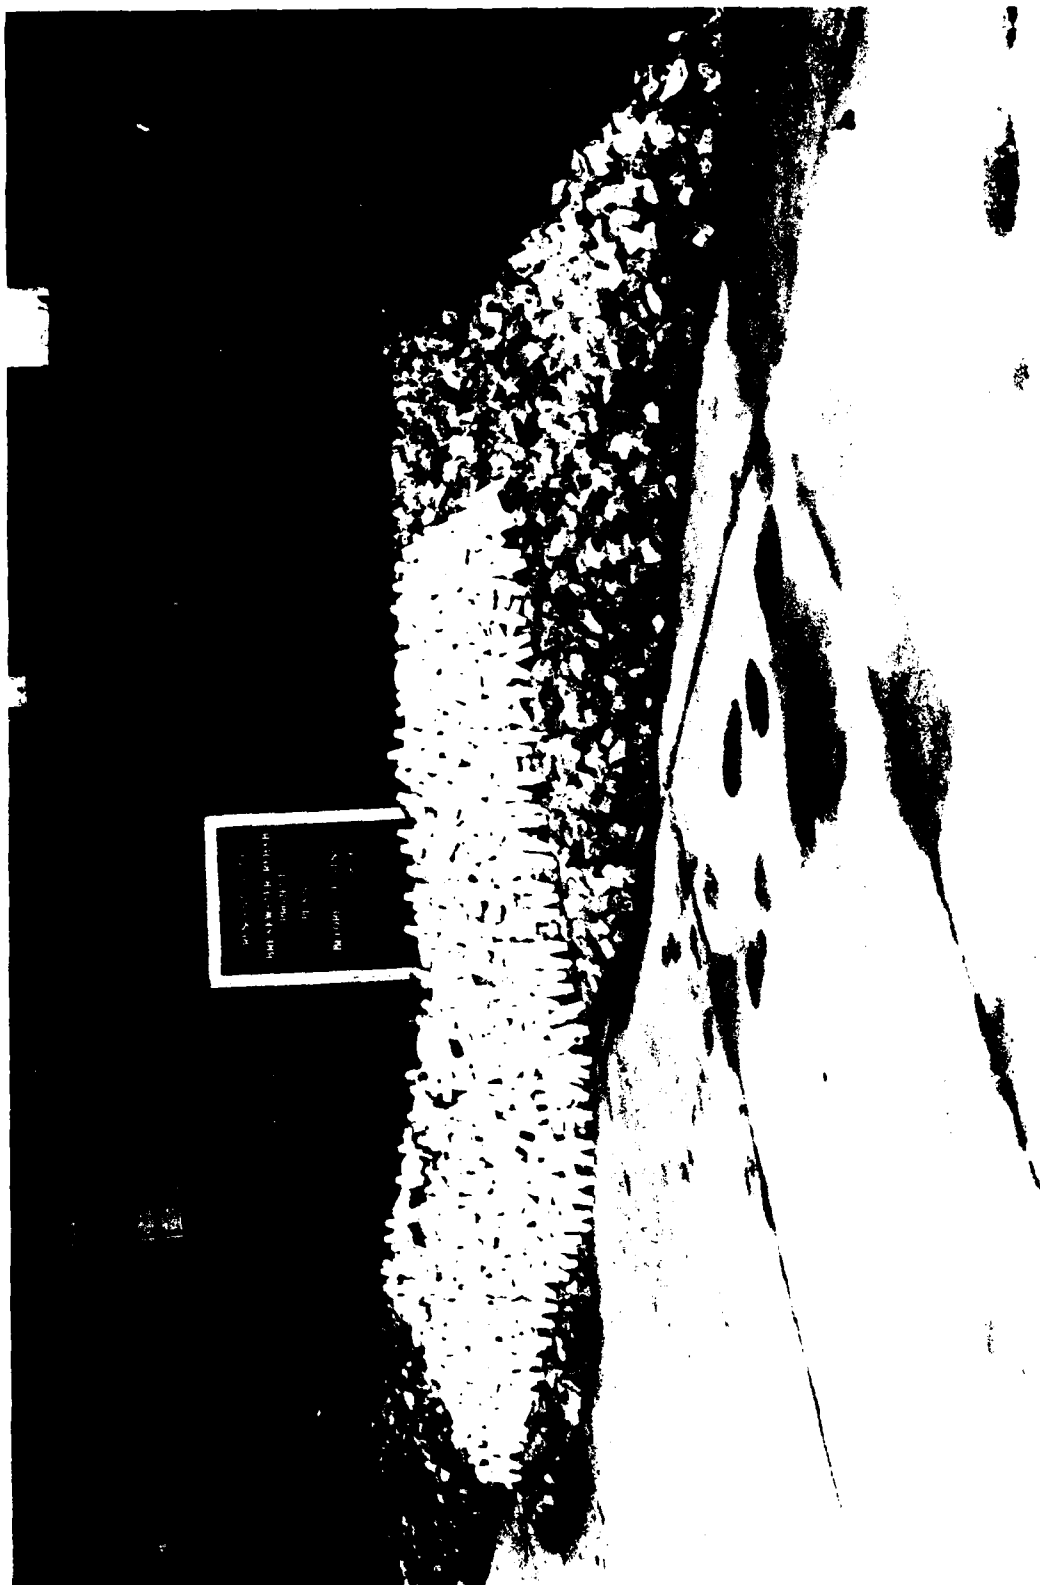
Photo 52. Seaward oblique view of Plan 5 before wave attack

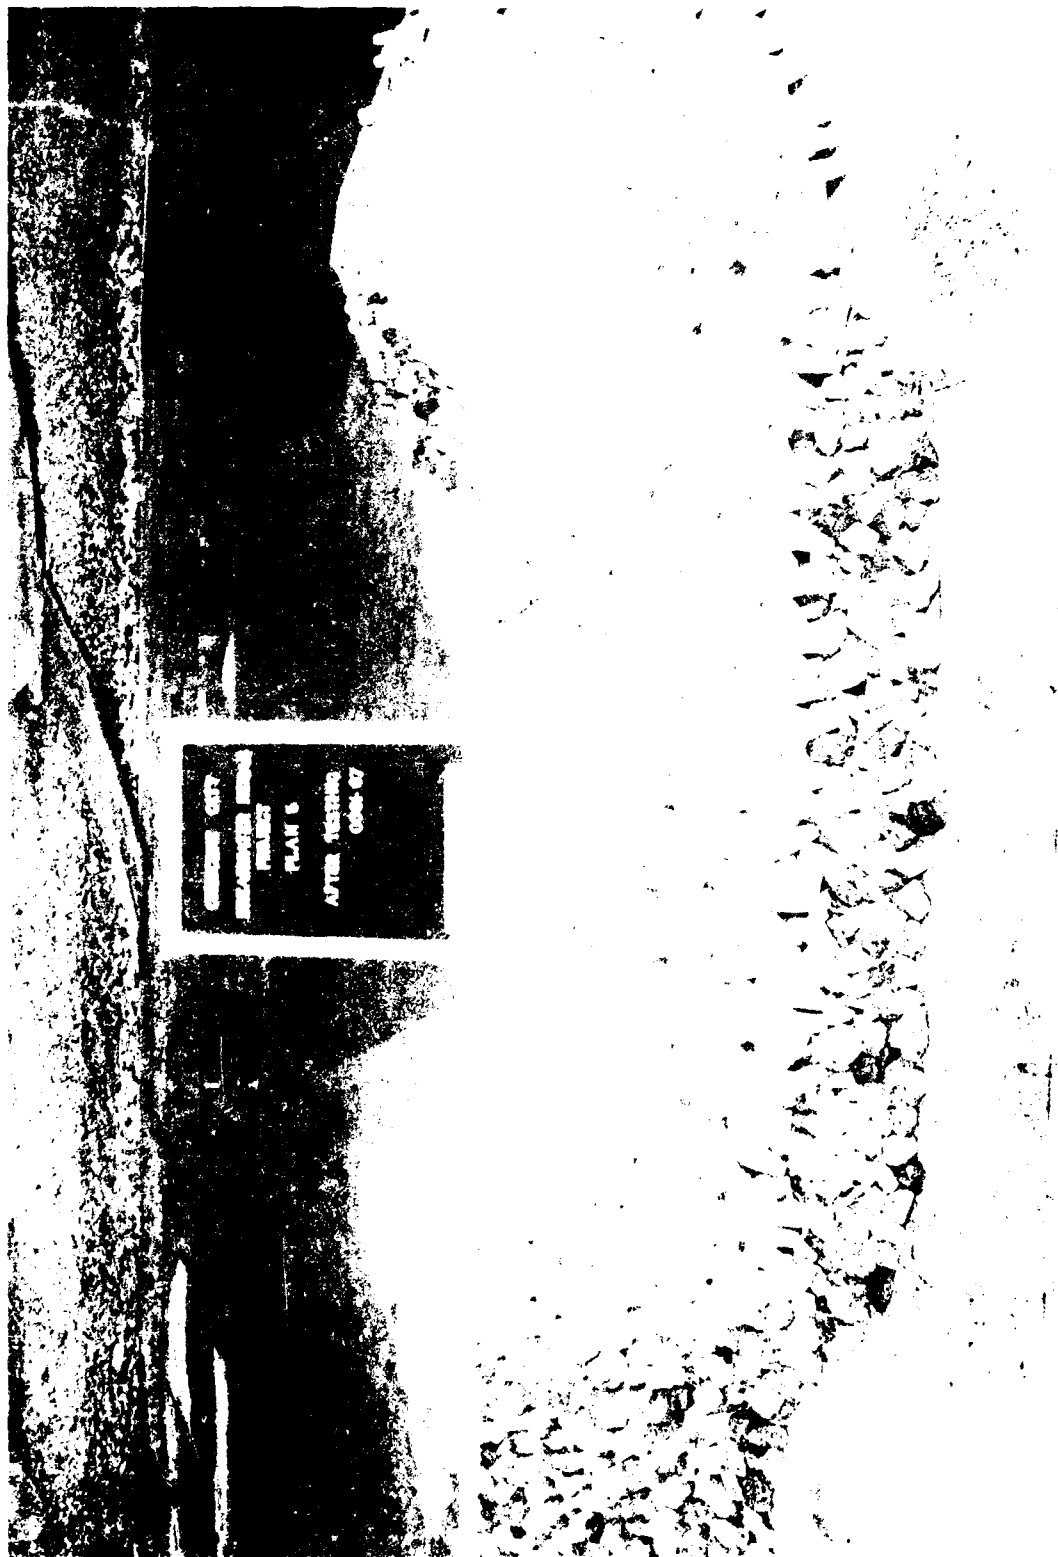
Photo 54. Sea-side view of Plan 5 after completion of abbreviated hydrograph
